Inspection Report Details

Record 1 - TEST, REPORT 123 YOUR STREET, SOME WHERE USA, DE 19702

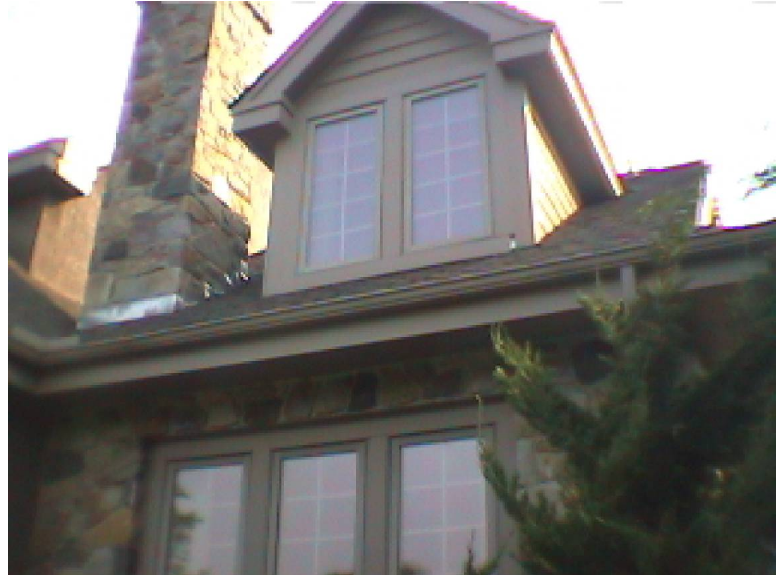
Major Defect Soffit\Fascia - Wood

Loose paint on soffit and fascia.
Badly rotted area noted at rear center dormer and loose trim noted on the front of the same dormer and should be repaired.

Rot on the left rear and loose trim on front

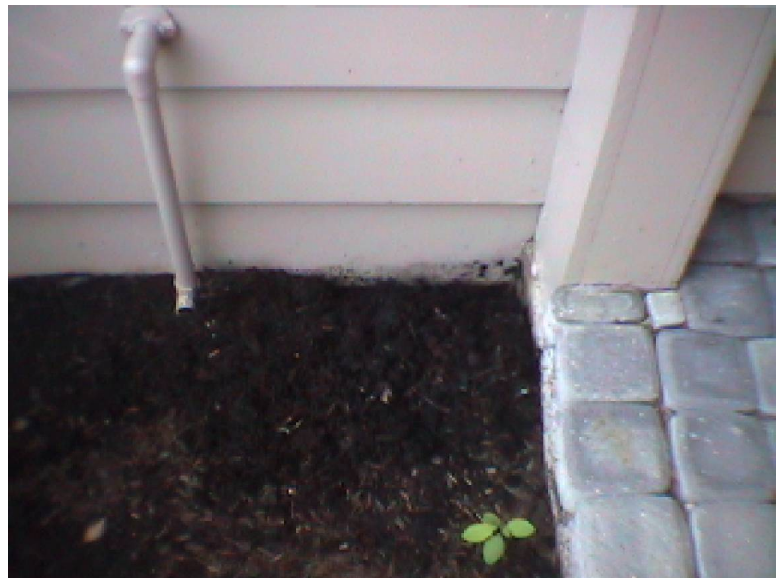
Service/Repair Siding - Wood

Siding makes soil contact and soil should be redressed to allow 6" to 8" of clearance should be created below siding .
No major wood rot where excavated but all areas not checked.

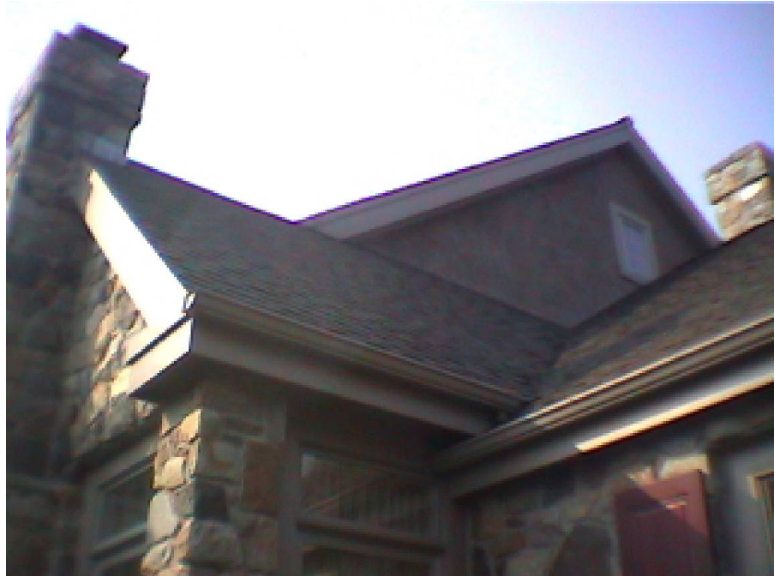
Roof Covering - Fiberglass

Some cracked, and damaged shingles and should be sealed noted also loose shingles noted on back of center of home and all should be repaired. shingles run short at the rear of dormer with chimney and should be extended to better protect fascia board at base of the valley.

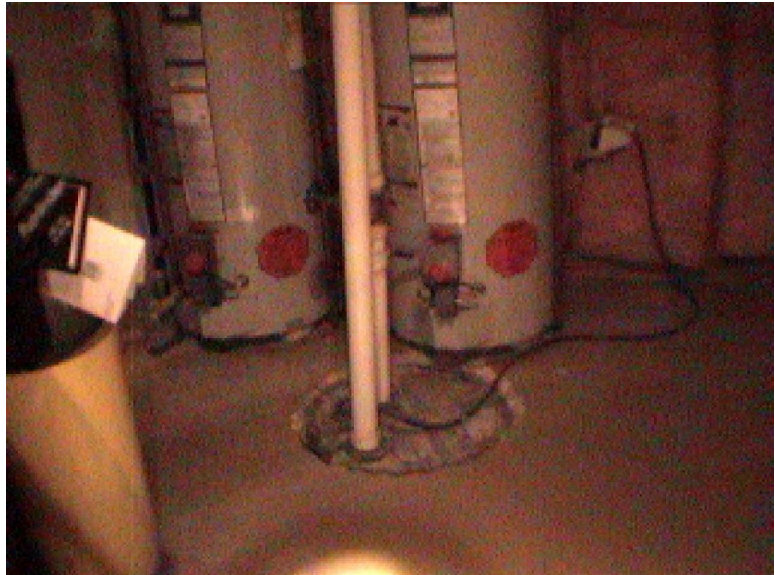
Service/Repair **PLUMBING - General Comment**

No check valve installed at injector pump and one should be.

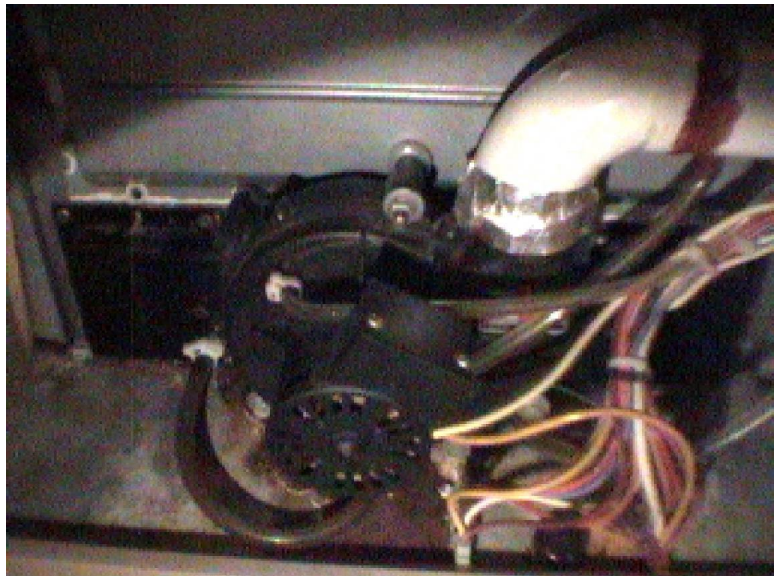
Forced Air System 1 Mfg. - York

Large unit has rust and some damage noted due to condensate leakage and should be monitored for future leakage as this model has a documented history of ID fan gasket and housing failures and if it has not been repaired it should be before heating season.

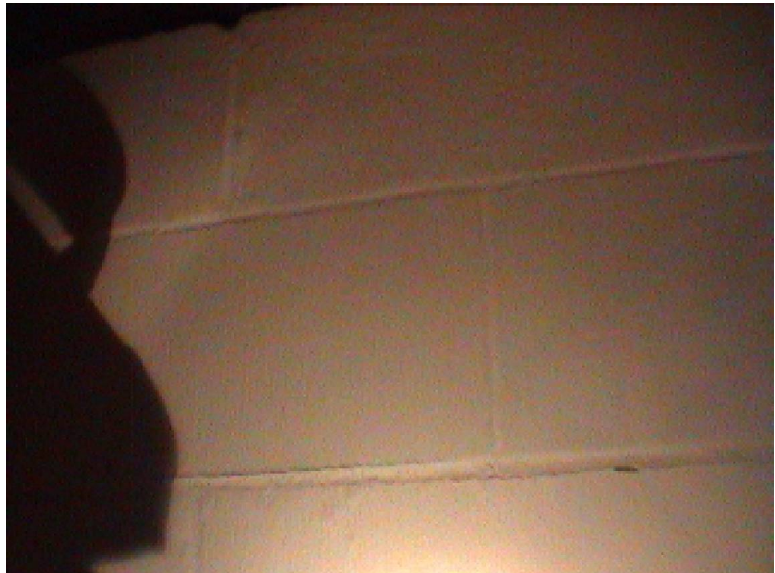
- Satisfactory **Basement Type - Full Percent**
- Satisfactory **Basement Access - Interior Stairs**
- Service/Repair **Basement Foundation Walls - Cement Block**

Some cracks and water penetration noted. Some horizontal cracks and slight bow noted and should be monitored for any change or evaluated by a structural contractor or engineer and any needed repair work done.

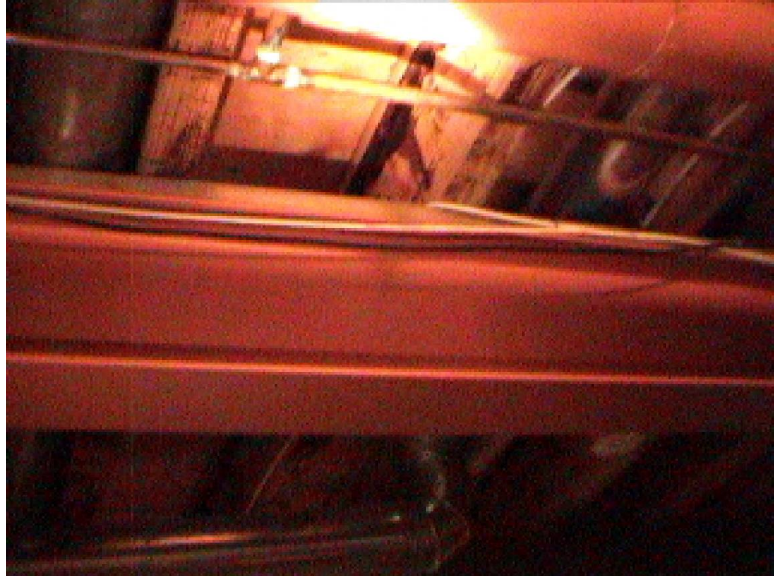
Basement Bridging - None

Some missing squash blocks noted and should be installed were I truss members cross main steel beam.
