# Inspection Summary

Record 1 - TEST, REPORT 123 YOUR STREET, SOME WHERE USA, DE 19702

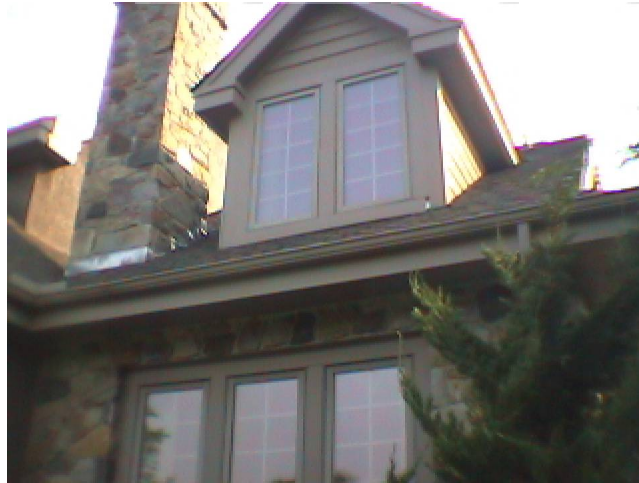
#### Soffit\Fascia

Loose paint on soffit and fascia.  
Badly rotted area noted at rear center dormer and loose trim noted on the front of the same dormer and should be repaired.

Rot on the left rear and loose trim on front

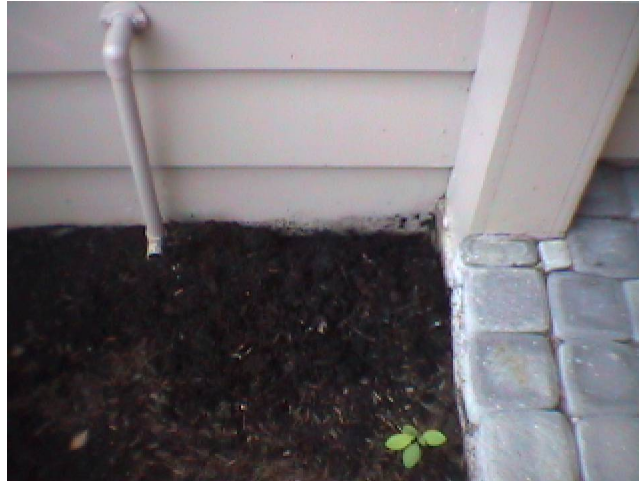
### Siding

Siding makes soil contact and soil should be redressed to allow 6" to 8" of clearance should be created below siding .  
No major wood rot where excavated but all areas not checked.

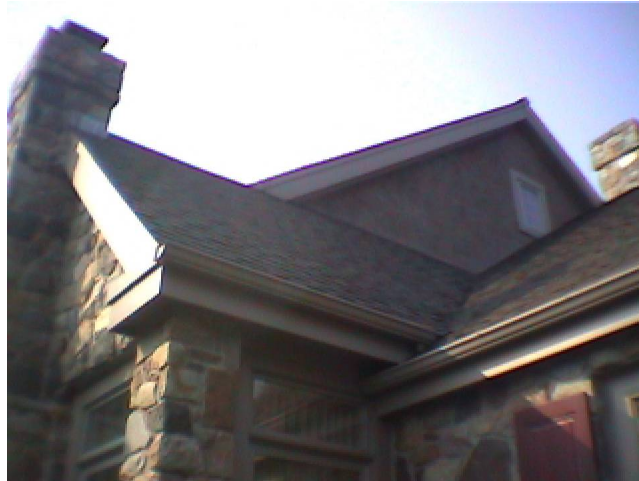
#### Roof Covering

Some cracked, and damaged shingles and should be sealed noted also loose shingles noted on back of center of home and all should be repaired. shingles run short at the rear of dormer with chimney and should be extended to better protect fascia board at base of the valley.

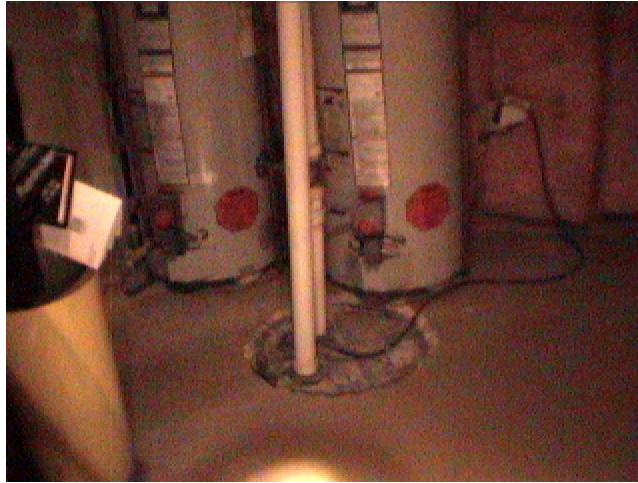
#### PLUMBING

No check valve installed at injector pump and one should be.

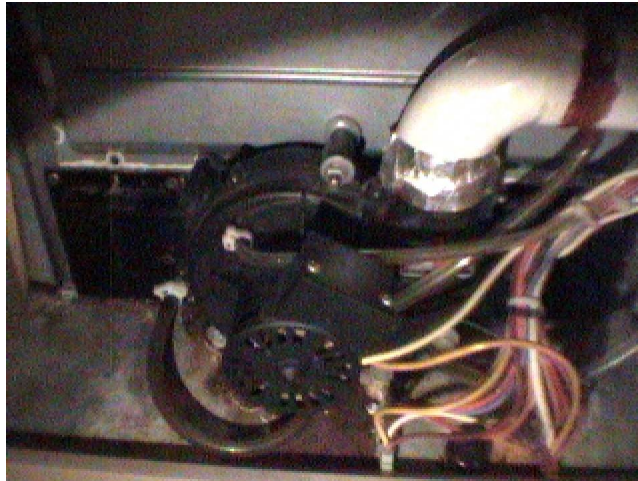
#### Forced Air System 1 Mfg.

Large unit has rust and some damage noted due to condensate leakage and should be monitored for future leakage as this model has a documented history of ID fan gasket and housing failures and if it has not been repaired it should be before heating season.

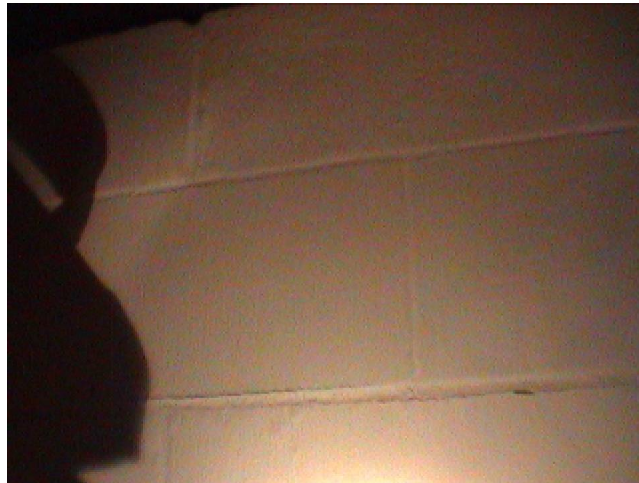
#### Basement Foundation Walls

Some cracks and water penetration noted. Some horizontal cracks and slight bow noted and should be monitored for any change or evaluated by a structural contractor or engineer and any needed repair work done.

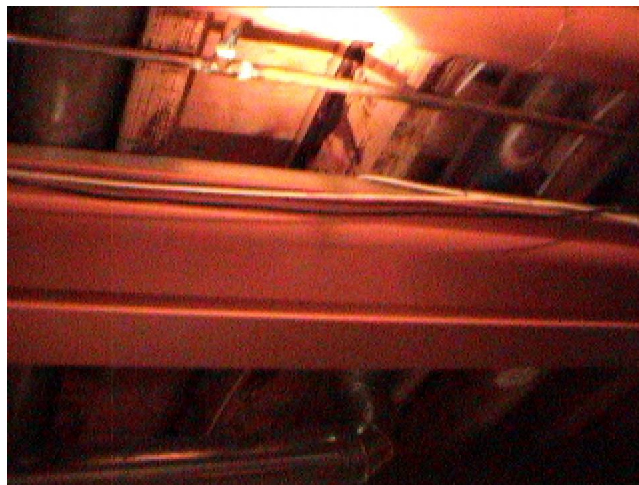
#### Basement Bridging

Some missing squash blocks noted and should be installed were I truss members cross main steel beam.
